Historic Resources Technical Report
20 North Almaden Avenue
San José, California

Daniel David Shoup, MUP, PhD
Archaeological/Historical Consultants
609 Aileen Street, Oakland CA 94609

December, 2014

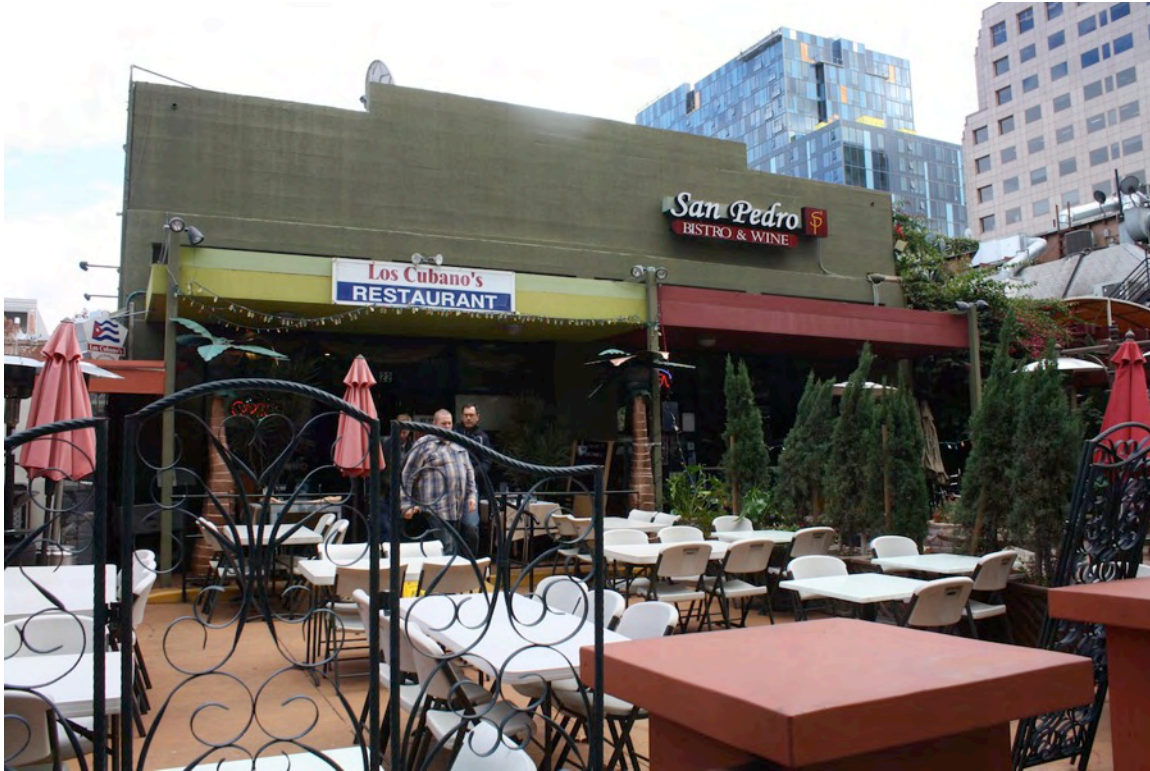
Figure 3: West facade, showing openings added in 1960.

The west façade has a stepped gable in plain concrete, with a slightly projecting rectangular concrete cornice and dentils. A central pillar partitions the west façade into two openings that serve as entrances to Los Cubanos Restaurant and San Pedro Bistro and Wine. A cloth awning 6' deep runs the length of the façade. As part of a remodeling for retail use in 1960, the west façade was opened to North Almaden Avenue via two glass doors in aluminum sash set in plate glass windows canted inward from the street. At this time, the projecting concrete bays over the two new entrances were added, along with the stepped roofline visible today (Figure 3).

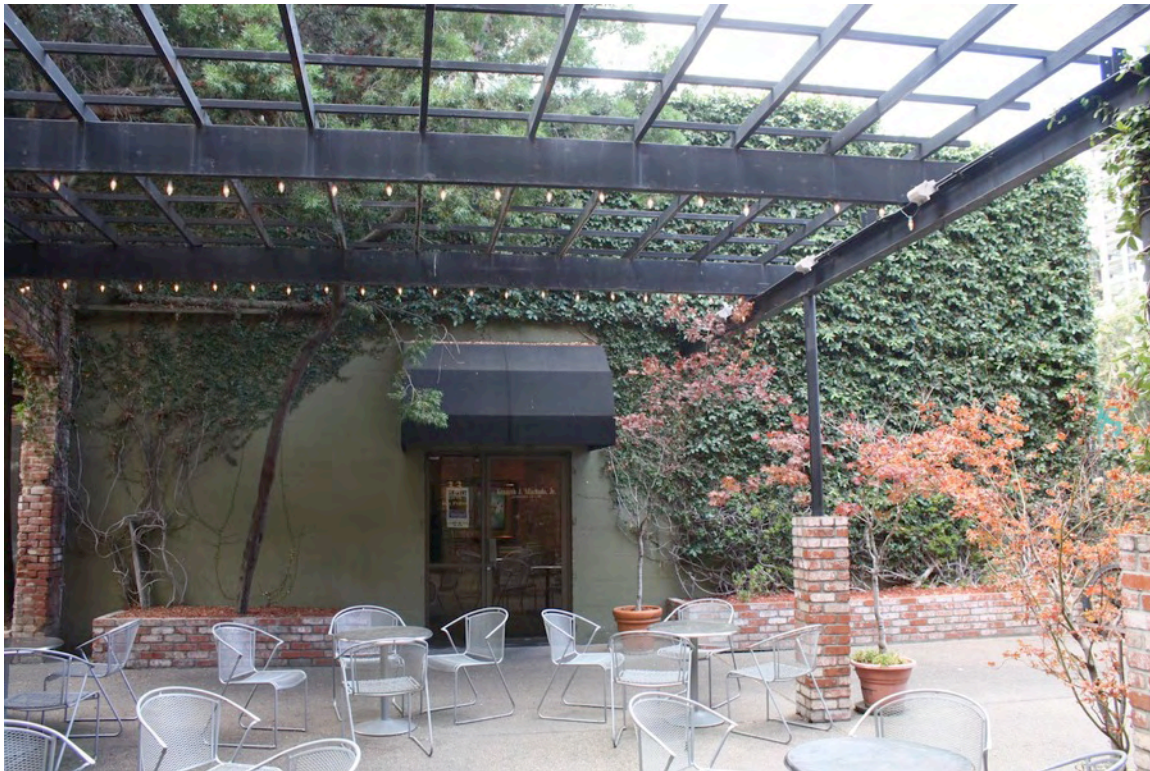
Figure 4: East facade, showing door to law office.

The east façade has a stepped gable in plain concrete, currently covered largely in ivy. A glass door set in the center of the façade provides entry to a suite of law offices. A cloth awning sits over the door. The east façade faces a patio with a metal trellis and brick landscaping detail (Figure 4).

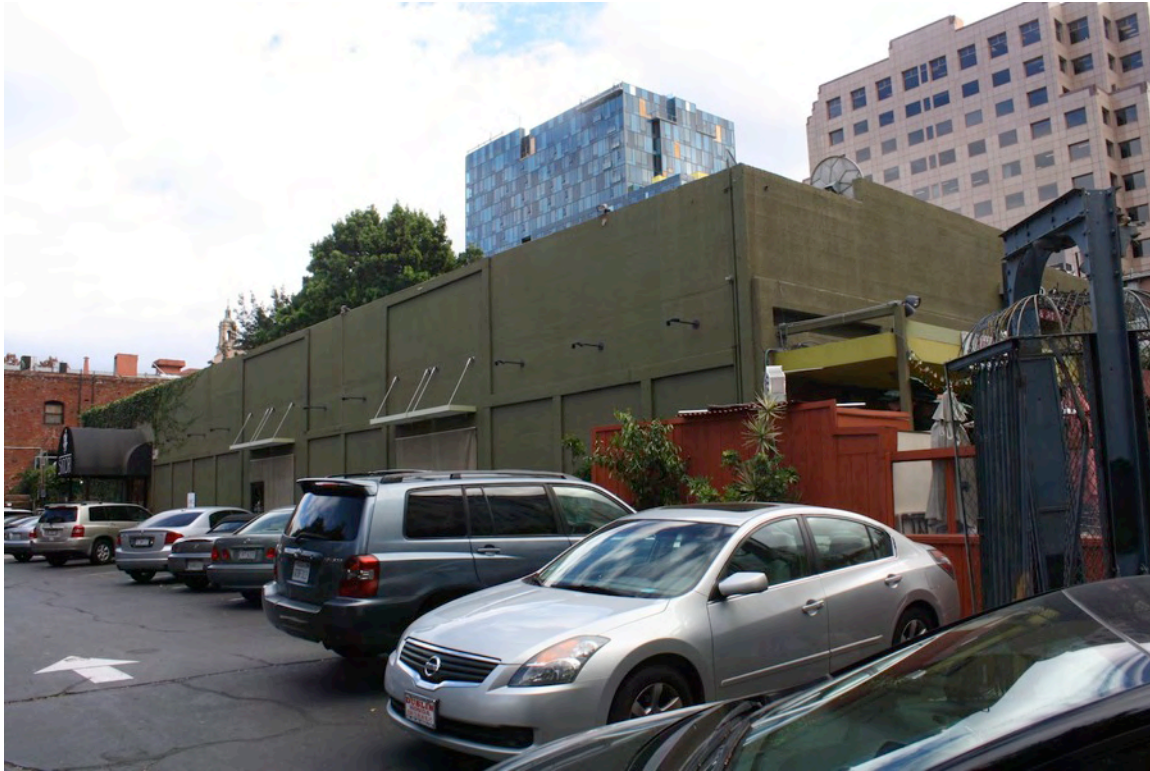
Figure 5: North and west facades.

The north façade is unfinished concrete divided into bays by the attachment of wooden planks. Three openings with awnings, corresponding to the locations of steel rolling doors on the 1945 plans, provide entryways to the Satori tea bar and Los Cubanos Cuban Restaurant. These openings are plate glass doors in aluminum sash (Figures 5 and 6).

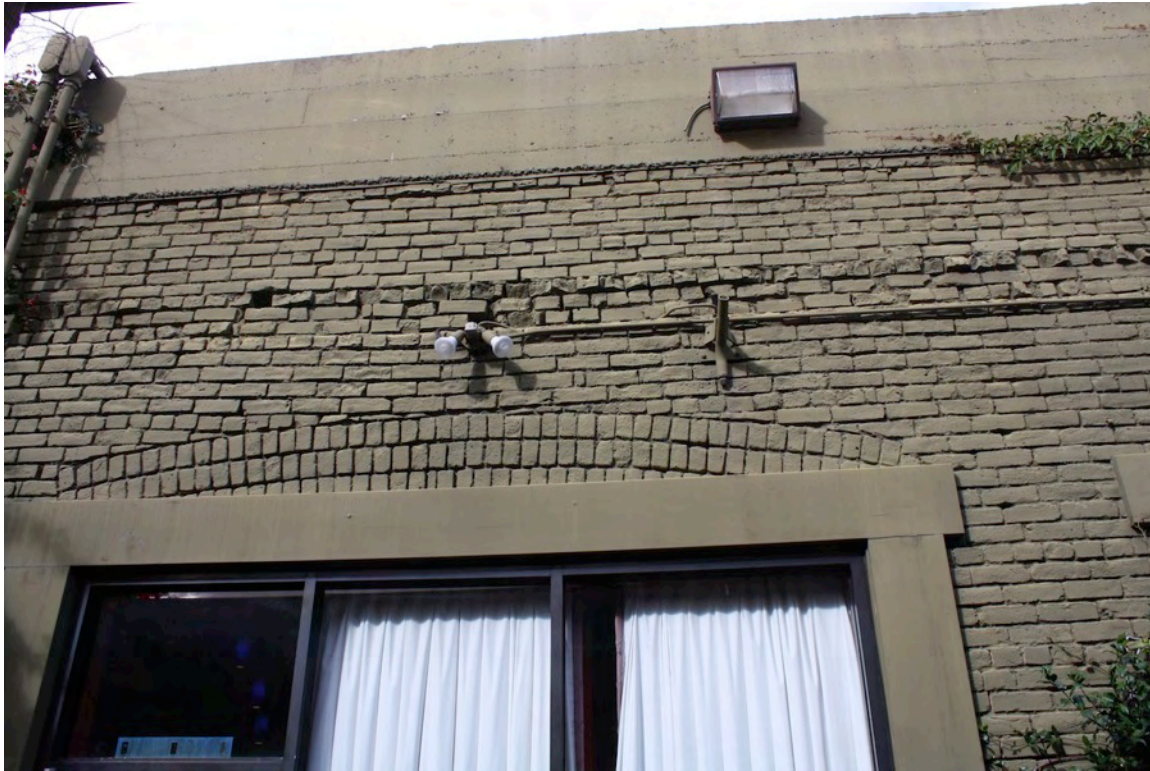
Figure 7: South facade detail showing 1880s brick wall. Note concrete framing and sash installed in original warehouse doors and concrete cornice, both added after 1960.

The south façade was originally the north wall of the first pipe and hardware warehouse of the Farmer's Union complex, constructed between 1884 and 1891 and demolished after 1962. A concrete cornice was added on top of the brick when 20 North Almaden Avenue was constructed, raising the height of the wall by approximately 2'. The south façade has two arched openings approximately 10' wide, which originally served as warehouse doors. These openings have been re-framed with rectangular concrete members that now hold plate glass doors and appurtenant aluminum sash (Figure 7).

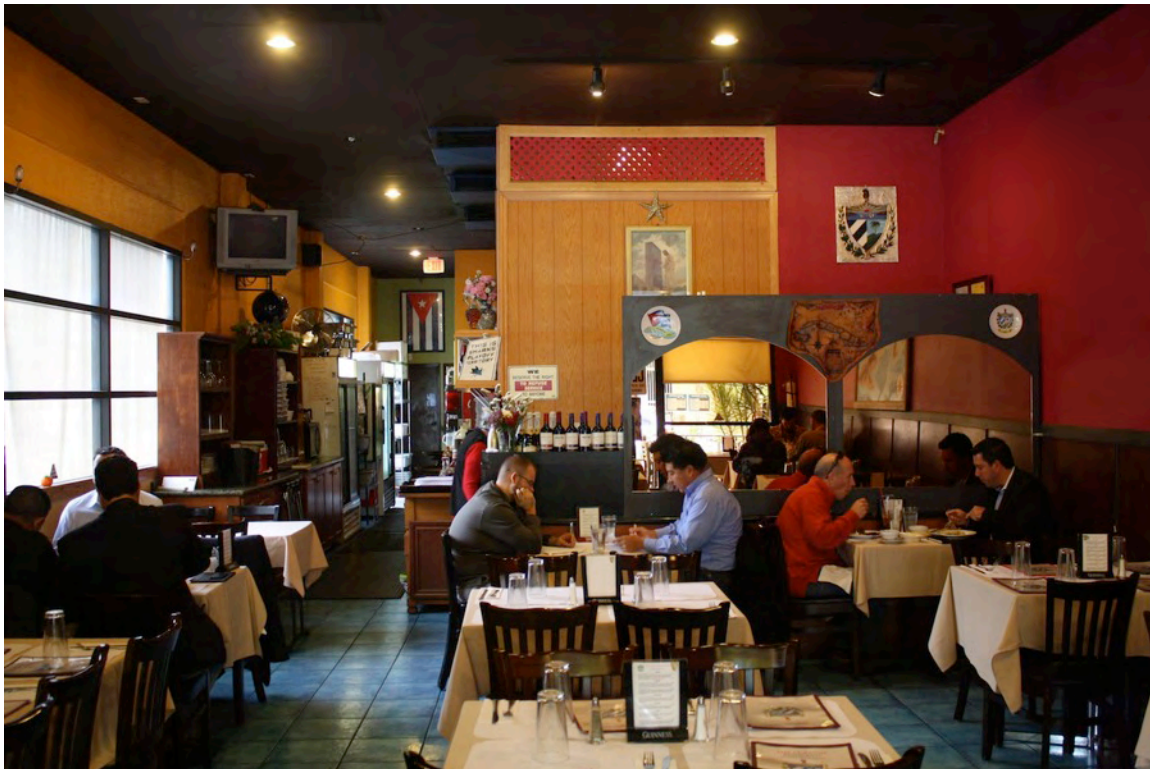
Figure 8: Interior of restaurant. Note drop ceiling added in 1960.

The original structure was built on an open plan. The interior of the building was subdivided in 1960 into three spaces and in the later 1960s into four. The western half of the building is currently divided symmetrically into two restaurant spaces that front on North Almaden Avenue. These spaces feature 12'6" drop ceilings and tile floors, with rear areas partitioned to provide space for kitchens and restrooms (Figure 8). The eastern, rear part of the building is irregularly divided into a retail space (currently occupied by a tea shop) that opens north onto the parking lot, and a law office with a reception area and two office rooms, which opens onto the east façade patio via a plate glass door in aluminum sash. In both rear spaces the ceiling is open to the full height of the roof, with steel trusses and wooden roof boards visible (Figure 9). The roof trusses are attached to concrete pillars on the north, east, and west walls, while along the south wall the roof trusses are supported by vertical steel members bolted to the brick.

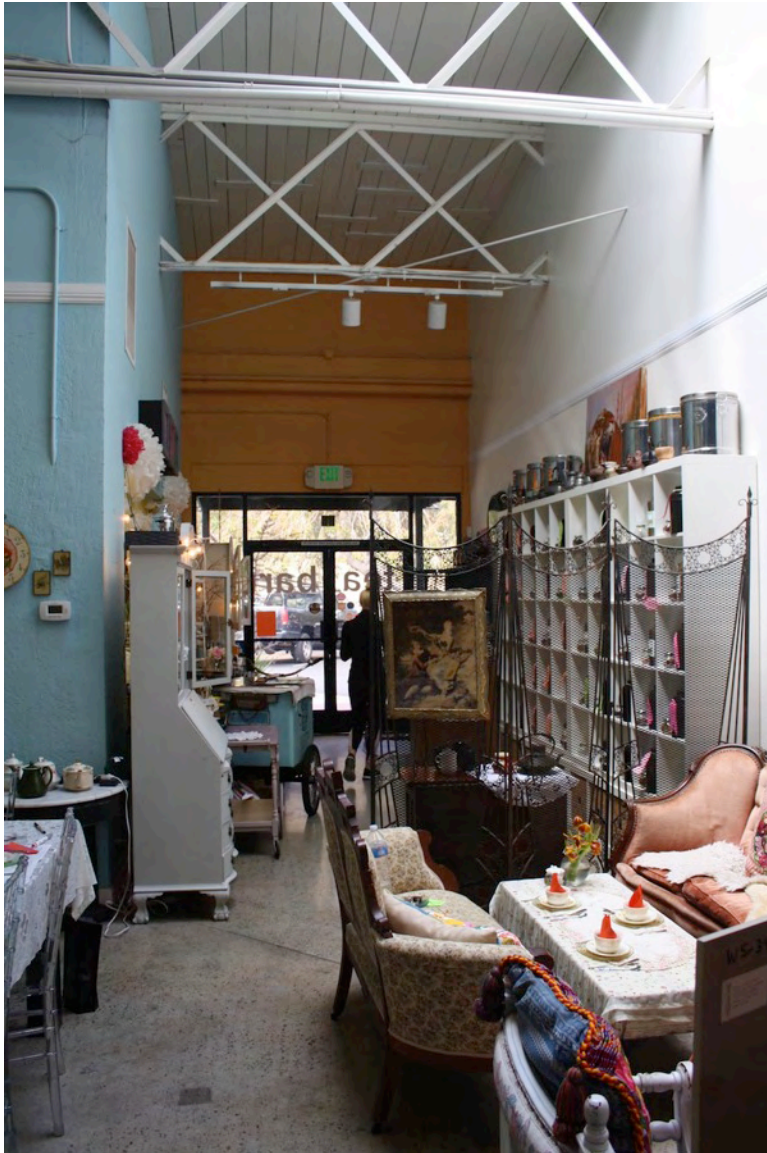
Figure 9: Interior of tea shop in eastern half of building. Note exposed steel trusses and wood plank roof.
